DEMOLITION

Sweet DEAL

**EARTH SERVICES & ABATEMENT
DEMOLISHES UNSAFE SUGAR
FACTORY, SAVES OWNERS MILLIONS**

Earth Services & Abatement saves owners of old, dangerous sugar factory in Colorado millions of dollars with open-air demolition process.

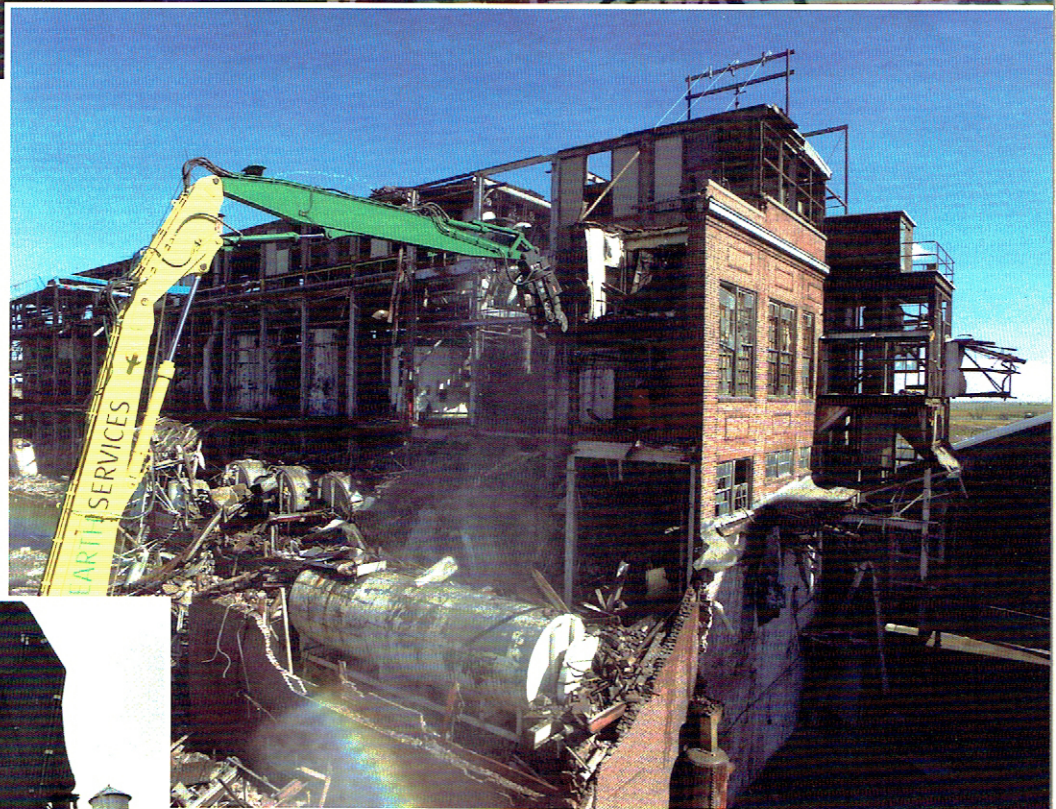
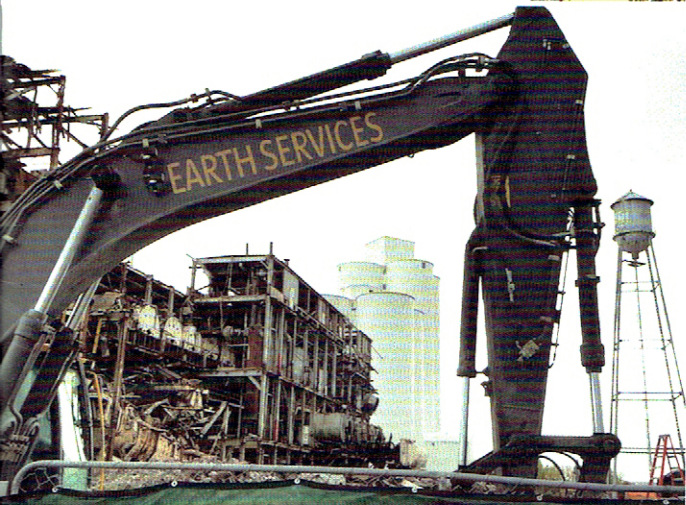
ESA excavator next to partially demolished Mill Building. Newer silos in the background will remain standing.

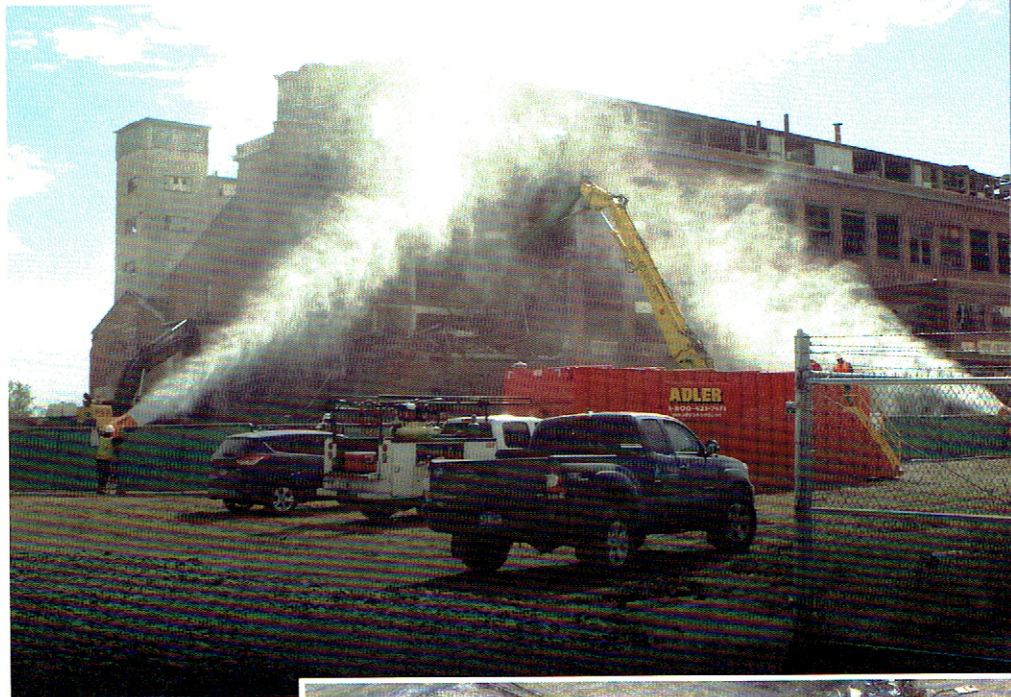
Wet methods were paramount to control air quality. The mill structure debris were pre-wetted for a period of no less than 45 minutes by the use of 18,000 CFM water cannons set to "mist." The AMS/BI set air samples in designated locations prior to beginning demolition activities.
